Type 6 Engine Burn Over
Facilitated Learning Analysis
October 5, 2011

Mound City fire Engine Burnover

Facilitated Learning Analysis

October 5, 2011

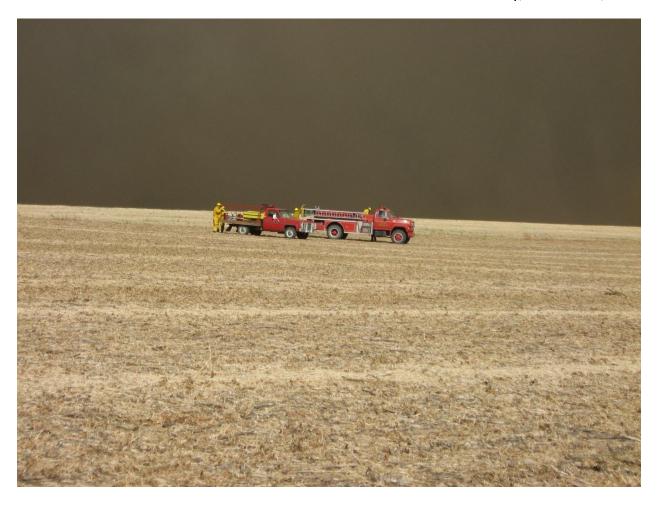
Type 3 and Type 6 engine working in Tandem. **Notice: all firefighters were wearing full PPE**

In this incident, a policy of running engines in pairs or in tandem saved lives. It is recommended that all Fire Departments and agencies follow this policy when fighting fires in the grass and crop fuel models.

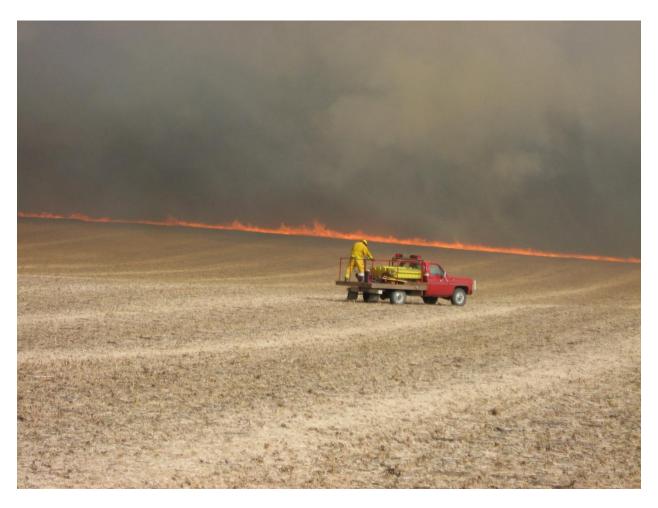
Fire Behavior on the northwest flank/shoulder of the fire prior to the burn over.

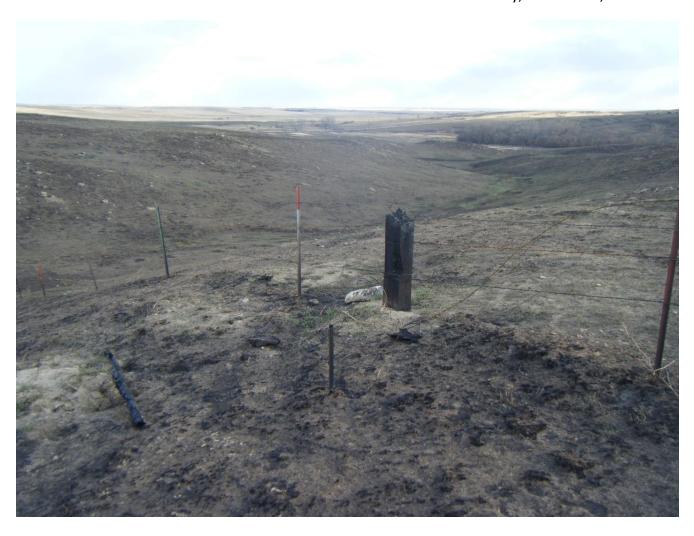
There was a wide drainage to the southeast of where Type 6 engine was burned over. It is believed that a slight southeast shift in the wind caused the head of the fire to climb the slope of the drainage at a higher rate of spread and closed the distance between the Type 6 engine and the head of the fire in a very short period of time.

Drainage just east of the burn over site which added to the increase of fire behavior.

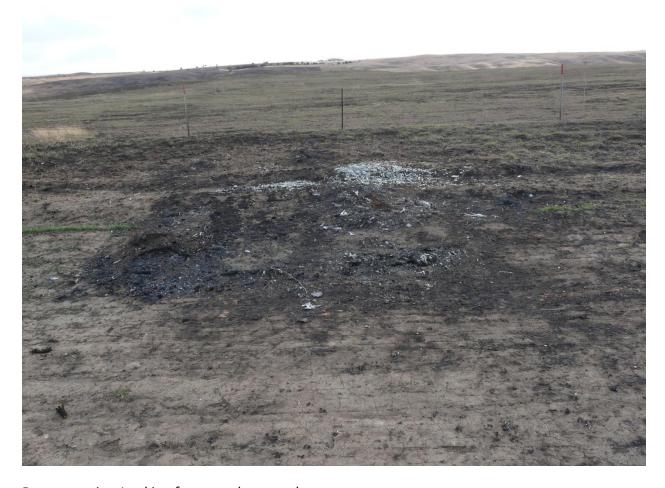
After returning to the area of their Type 6 engine, fire crews found the Type 6 engine had been totally destroyed by the fire.

Burn over site. Looking from north to south.

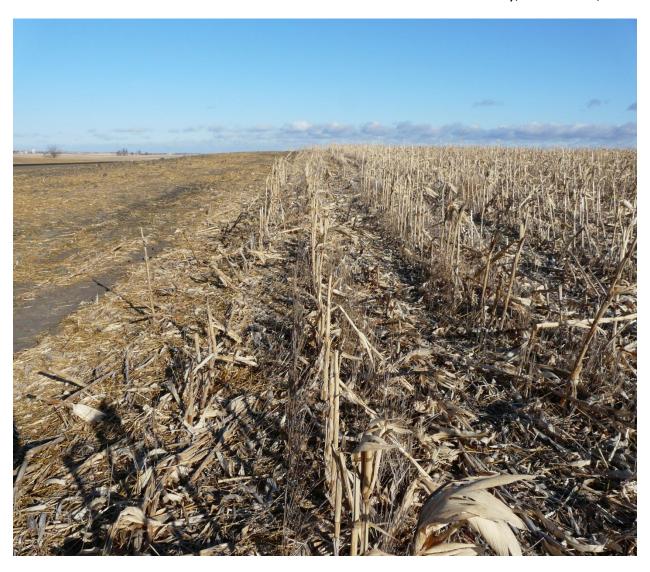
The no-till crop conservation methods used in the area greatly influenced the firefighter's perceptions of the fire behavior in this incident. Having a dead fuel moisture fuel bed of 24" to 30" wheat stubble as an understory in a mature corn field caused serious control problems on this fire. There were times when the fire would advance through the wheat stubble understory and camouflage the fire behavior in the mature corn. The fire would spread up into the corn canopy greatly increasing the fire behavior in some areas.

Corn stubble with a wheat stubble understory. Multi-layered fuel bed.

A fire behavior bulletin needs to be developed and distributed in areas where no-till farming practices are in use. The fire behavior on this fire was greatly influenced by the fire burning through the wheat stubble understory in mature corn fields. The fire rate of spread and direction was hidden at times by the mature corn canopy.

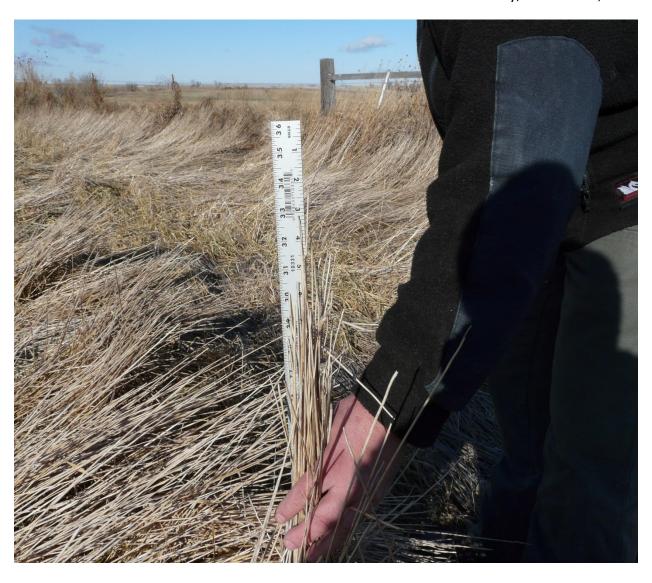
It should be noted that no-till farming practices were used in the area of the burn over. This practice is used to conserve equipment fuel costs as well as for soil conservation. In a no-till area wheat is often harvested using a combine clipper head that cuts the wheat off just below the head leaving a stubble field of 24 inches or more after the harvest. The following season, corn is then planted in the wheat stubble. When the corn has grown above 24 inches in height, there is still cured wheat stubble available as fuel in an understory. It was noted that there were several areas of the Mound City Fire that the fire burned through the wheat stubble understory basically being camouflaged by the mature corn fields.

No-till farming practice. Residual wheat stubble after harvest.
